Repair Manual

to restore power supply of the sound module Ketron SD1000 from USB port

(Fault cause: contact failure of an internal switch (pins 2 and 3). See the last page of the instructions (a drawing of the power socket DJK-02A).

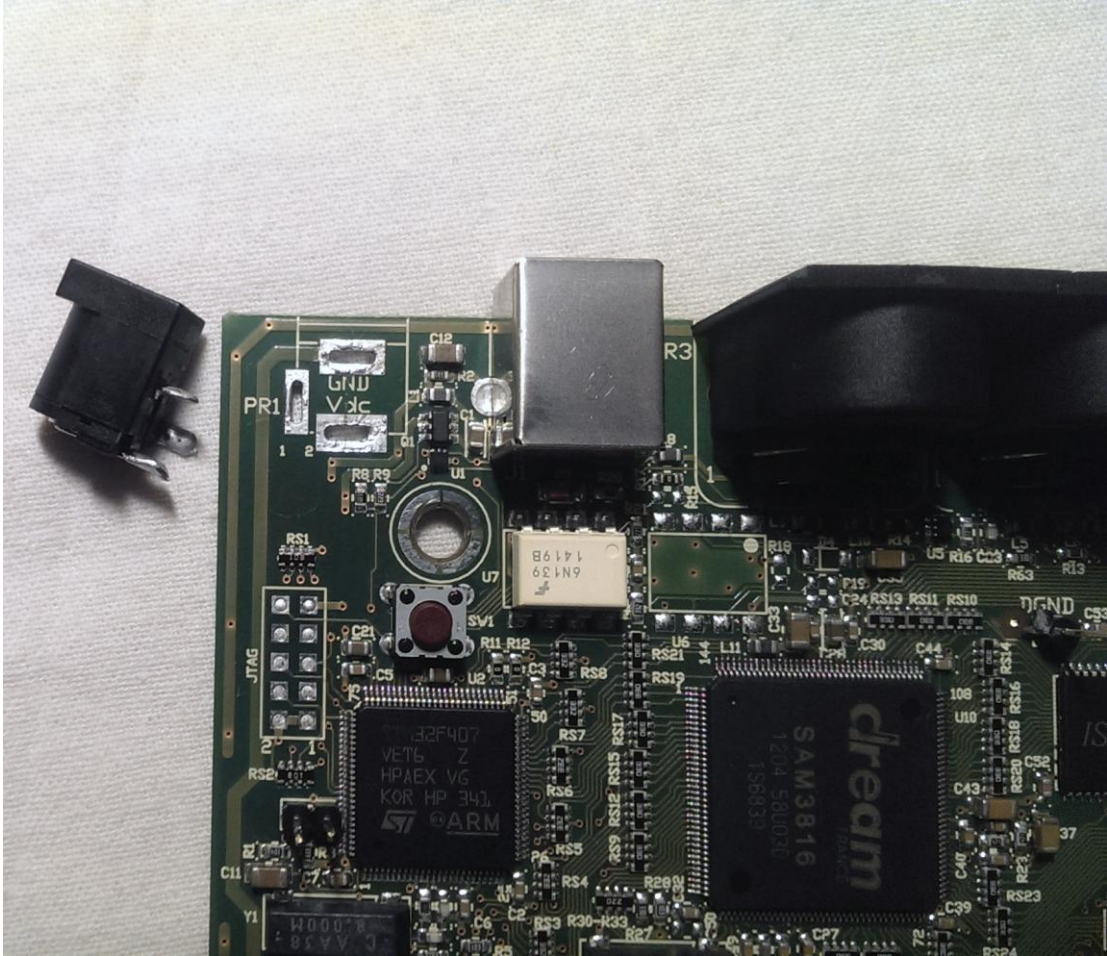
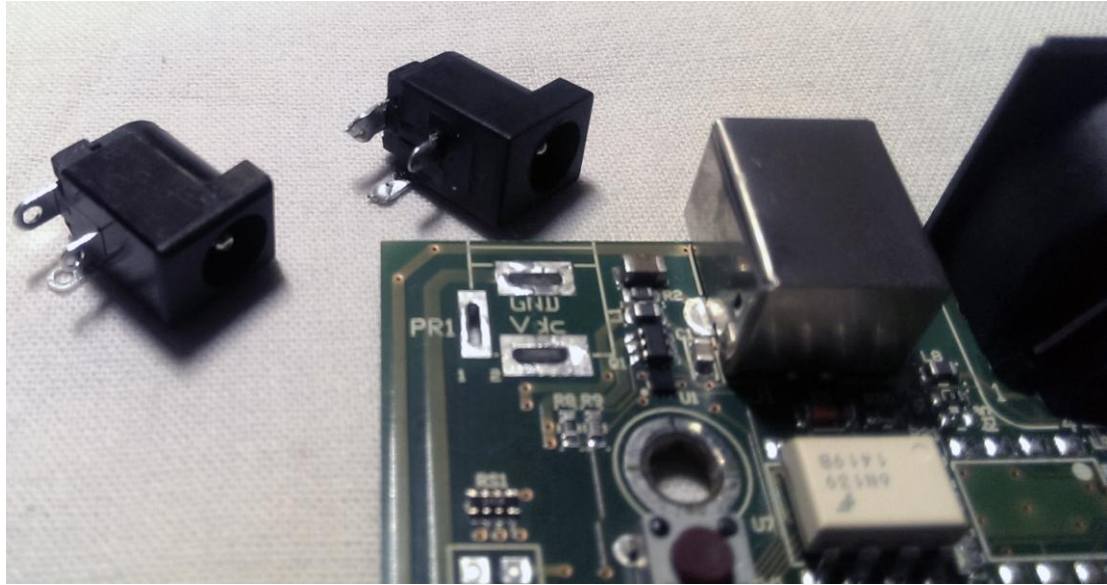
DC Power Jack Socket 3015 3-pin (connector 5.5x2.1mm), other designation: K375A, DJK-02A

This method of Troubleshooting the power supply from USB, does not guarantee against the recurrence of defect. The best solution is to replace of the Power socket 5.5x2.1 mm on similar, but higher quality. See below =>
